# Home Inspections For You LLC

**Property Inspection Report**

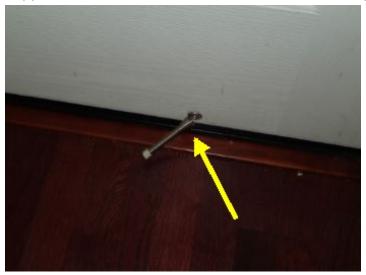
Stopper on the front door is broken. Recommend replacing.

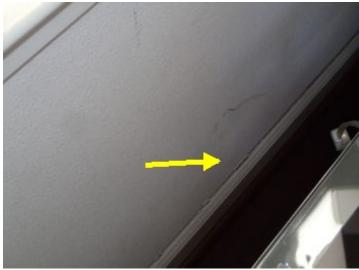
Baseboards along the living room north wall need to be recaulked.

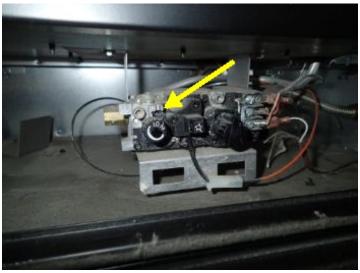
The fireplace appears to be in fair visual condition. The controls under the fireplace were in the off position during the inspection.

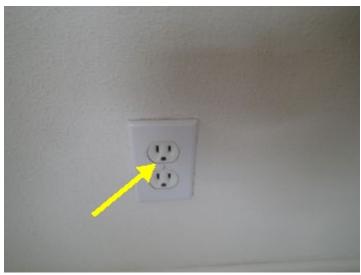
There is a grounding pin stuck in an outlet in the Master bedroom outlet has been fixed. 1/31/2019. master bedroom. Needs to be repaired.

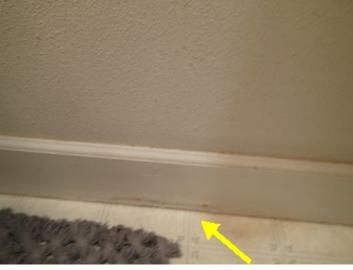
Slight water damage along the baseboard in the downstairs half bath.

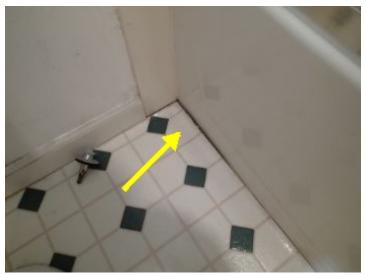
Water damage noted in the upstairs main bath along the tub. The vinyl flooring is peeling up. The subfloor is not visible to determine the extent of the water damage. I recommend a licensed contractor who specializes in flooring make any necessary repairs.

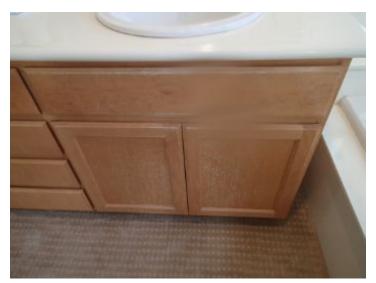
The finish on the cabinets is damaged. This is normal wear and tear.

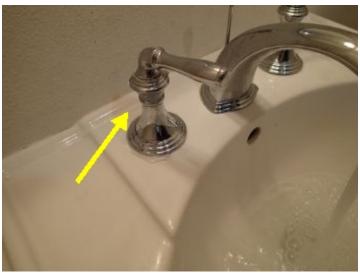
- \*\*DRAINS\*\* · No deficiencies observed.
- Stopper is missing/inoperable. Master bath left sink.
  \*\*SUPPLY\*\*
- Operated normally, at time of inspection.
- Faucet leaks at hot water handle. Downstairs half bath.

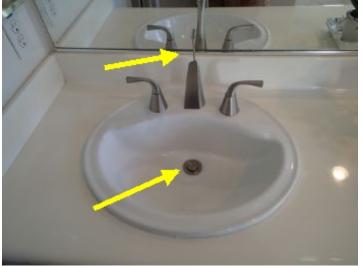
Faucet leaks at hot water handle. Downstairs half bath.

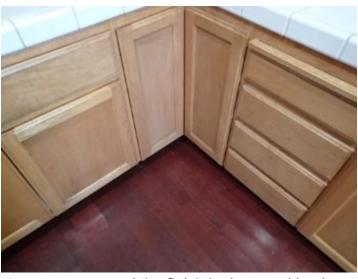
The surface of the cabinets are greasy, and the finish is damaged in places. Normal wear, and tear.

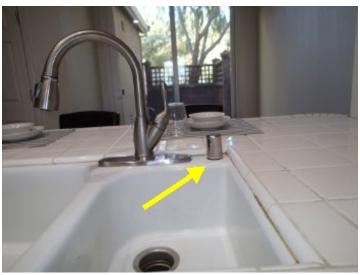
The dishwasher drain line/ air gap leaked under the sink when the dishwasher drained. Recommend a licensed plumber repair.

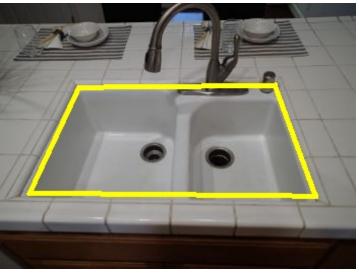
- AINS\*\*
- Functional drainage noted.
- \*\*SUPPLY\*\*
- Operated normally, at time of inspection.
- Suggest caulking as necessary.

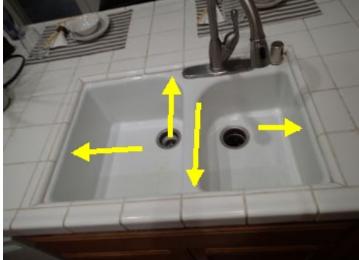
Suggest caulking as necessary.

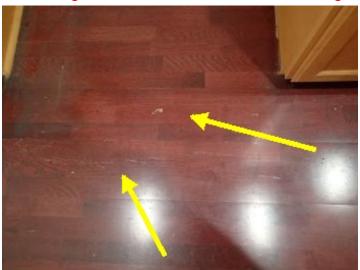
The flooring is scratched, and the finish is damaged in areas.

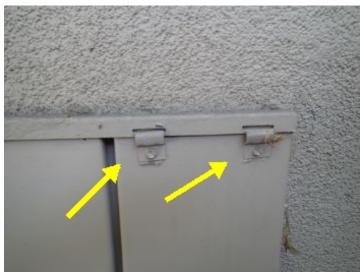
The main panel cover is loose. Needs to be secured.

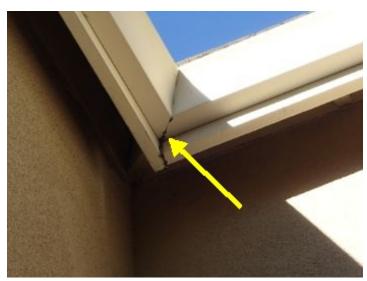
Gutter seam on the second story visible from the rear patio appears to leak. Recommend sealing.

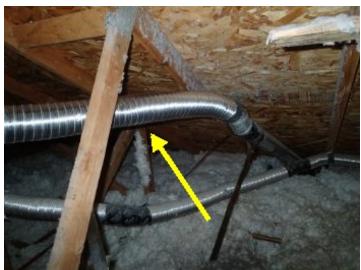
Dryer vent has been properly vented to the outside 1/31/2019.

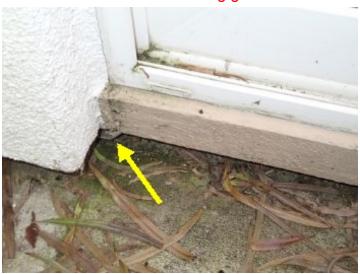
Wood rot noted under the sliding glass door. Recommend repair.

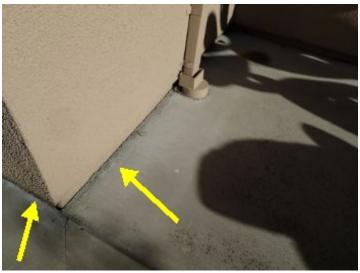
The walk way along the home should be sealed with a good caulk to help prevent water from draining along foundation wall.

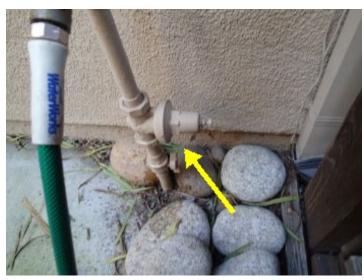
Pressure regulator noted. Needs to be adjusted.

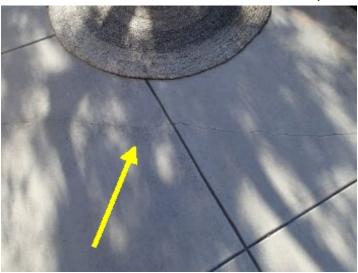
Common settlement cracks noted in the front patio area.
